Muskwa-Kechika: Redfern Access Management Area Route Restoration Analysis and Recommendations

Prepared For:
Mike Neto, Recreation Section Head
Ministry of Environment, Lands and Parks
400 10004 – 110th Ave.
Fort St. John, BC

Prepared By:
Chris Maundrell, R.P.Bio.,
Adlard Environmental
Brian Churchill, R.P.Bio.,
Chillborne Environmental

January 2007

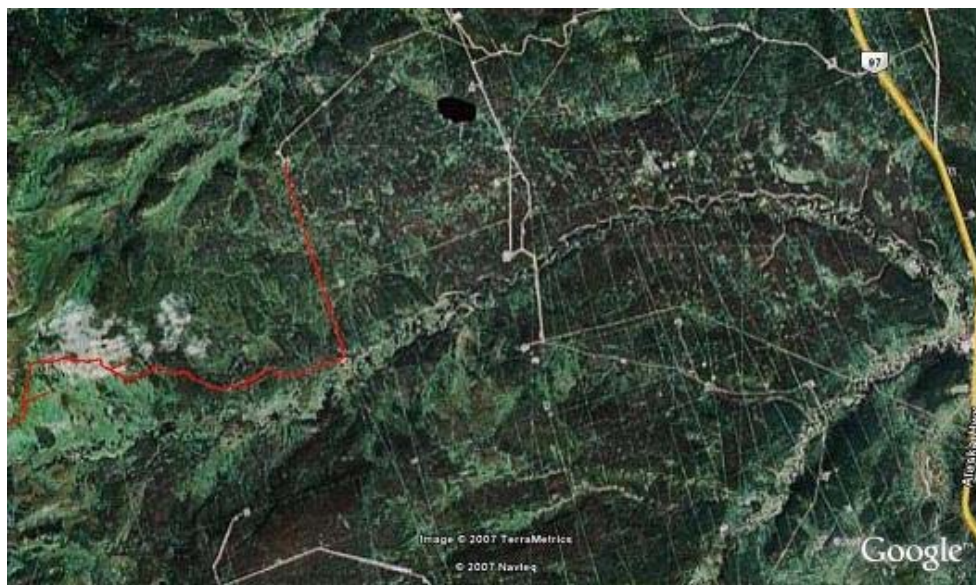
Figure 1: Staging area for trail (in Red) is off the Alaska Highway in the Impa Lake Area.

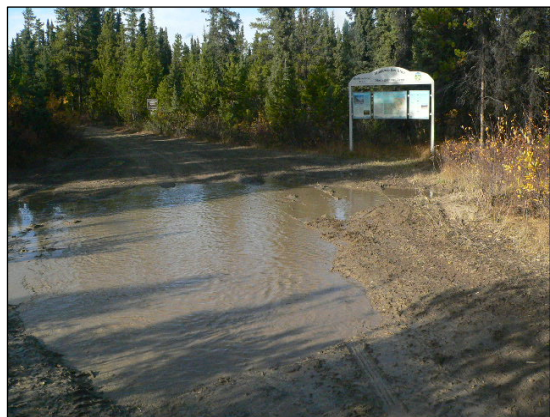
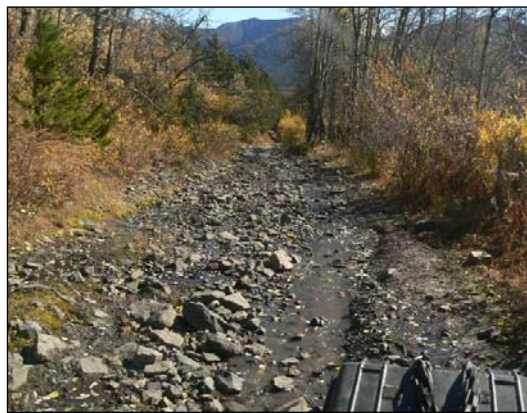
Water tends to remain on the trail for periods far beyond the spring freshet or after a rain event. In late September of 2006, a very dry year, we assessed the trail and found mud holes still being avoided by ATV riders as well as water in the middle or at times running down the middle of the trail (Figure 2 and 3).

Figures 2 and 3: water accumulation and water down the

3: water in low areas running trail.

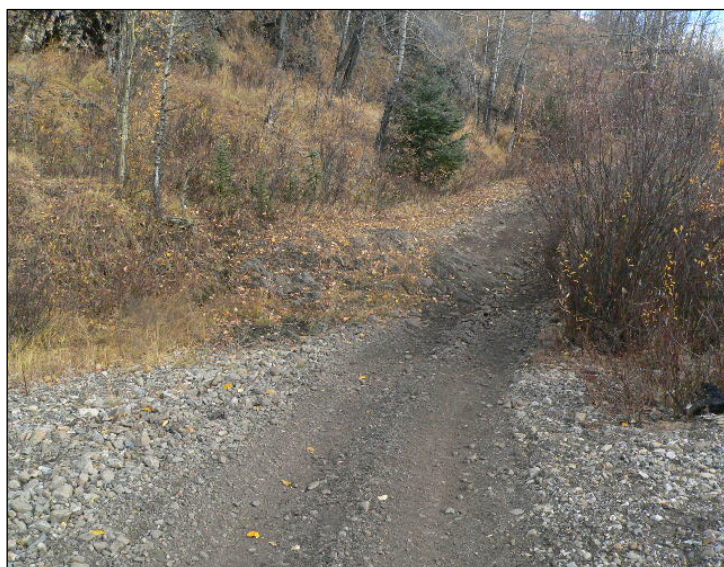
from the trail either naturally because of terrain or because of berms (Figure 4) that form the edge of the old road. The source of the berms is likely two fold. One source is the original construction of the trail which appears to have left a berm on the edges of the road without planned breaks for drainage. The second source is simply from repeated use of the trail without maintenance. This has forced soil materials to the edge of the trail where it has accumulated. In both cases the soil material along the edge of the road is now acting as a barrier to water moving perpendicular to the trail, forcing the water to remain on the trail or flow down the trail until it either accumulates to a level higher than the barrier or it finds a break through the barrier.

Figure 4. Berm on lower slope position of road restricts water movement.

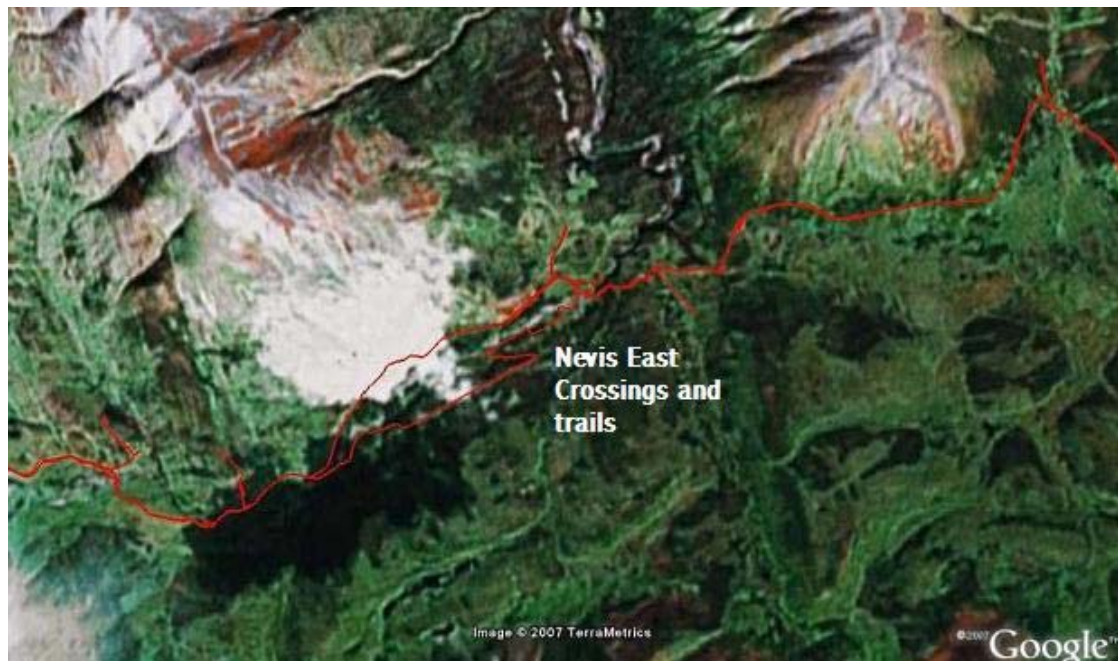
This creek crossing has numerous trails incised into the banks of the creek at a variety of crossing places (Figure 5). These crossings are particularly challenging during periods of high water as the water can be deeper than the ATVs ability to maintain solid traction to the ground and therefore can lead to swamping of the ATV, a particular concern to families (Moose ATV Club pers. com.). There is also concern that the crossings are in areas of fish habitat. Bull Trout and Arctic Grayling are known to occupy and spawn in Nevis Creek and the area at the

Figure 5 : Nevis East Crossing quad routes

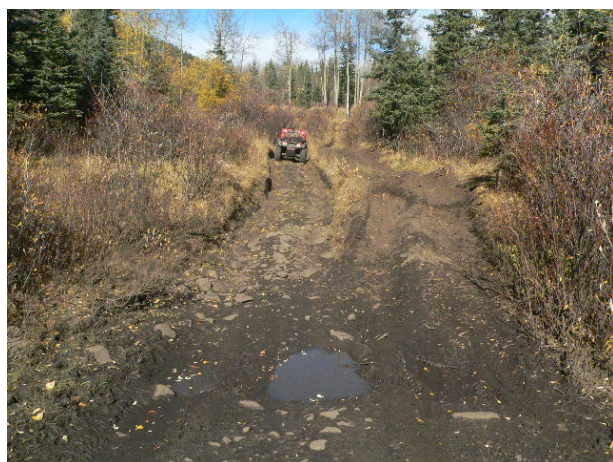
Where the trail goes through organic soils on the stream banks the tire action moves soil downhill and into the stream (Figure 6). Much of the stream bank at Nevis East is on rocky substrate but it is difficult to navigate off a rocky bank onto gravel bars or the shallow parts of the stream. Additionally at different levels of stream flow there appears to a different place that is “best” to cross this large stream. Consequently there has been much trial and error (within the 400 meter zone either side of the

designated trail) and a number of crossings now exist that show bank degradation where ATV traffic has caused ongoing bank erosion.

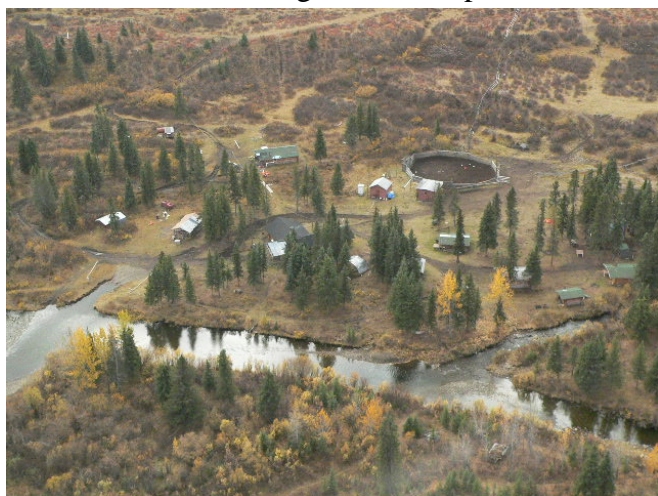
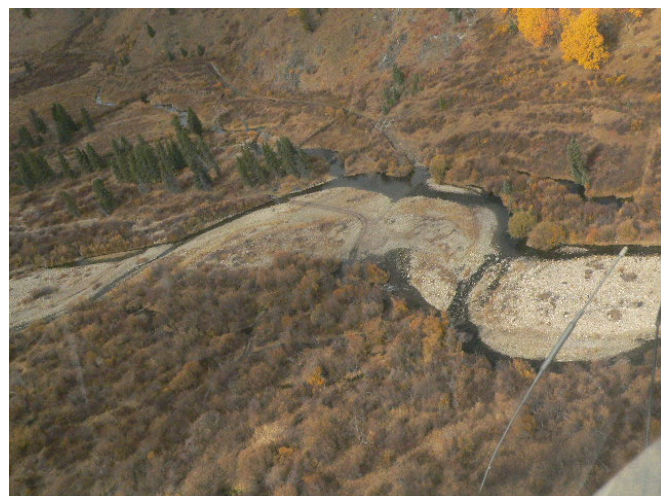
Nevis Camp is approximately 19 km from the M-KMA boundary. The trail crosses Nevis Creek in two locations, once in front (east Figure 7) of the main building at Nevis Camp and another approximately half a kilometre west of the camp (Figure 8). In between the two crossings the travellers must pass through Nevis Camp. Traffic through the camp can be an issue when young children are playing and horses are loose. Stopping at the camp is allowed and cabins are usually available for rent, however most people travelling the route are prepared for outdoor camping and don't use the camp for accommodations (Morley Dressler pers. com.). They simply drive through the camp. All travellers must take the route through the camp as there is no other alternative at this time. The creek crossings at the camp are wide and the trail is well incised into the banks of the creek

(Figures 7, 8) Nevis Camp Crossings (aerial)

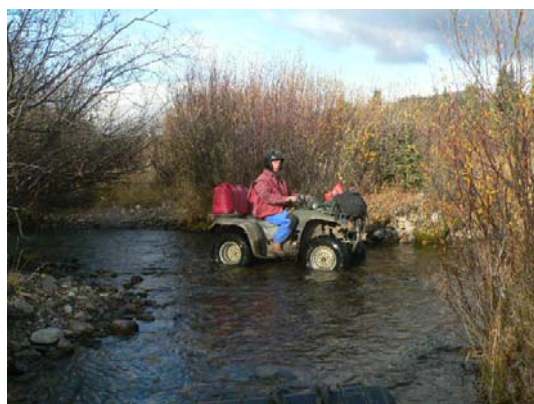
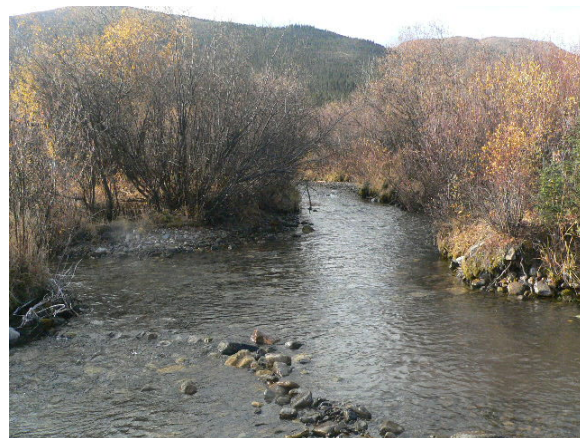
These crossings are particularly challenging during periods of high water as the water can be deeper than the ATV's ability to maintain solid traction to the ground and this lack of stability can lead to swamping of the ATV, a particular concern to families (Moose ATV Club pers. com.). There is also concern that the crossing are in areas of fish habitat. Current crossing at the west end follows along stream channels for approximately 100 meters. (Figures 9, 10)

Figures 9, 10: Stream Crossing in Channels west of Nevis Camp

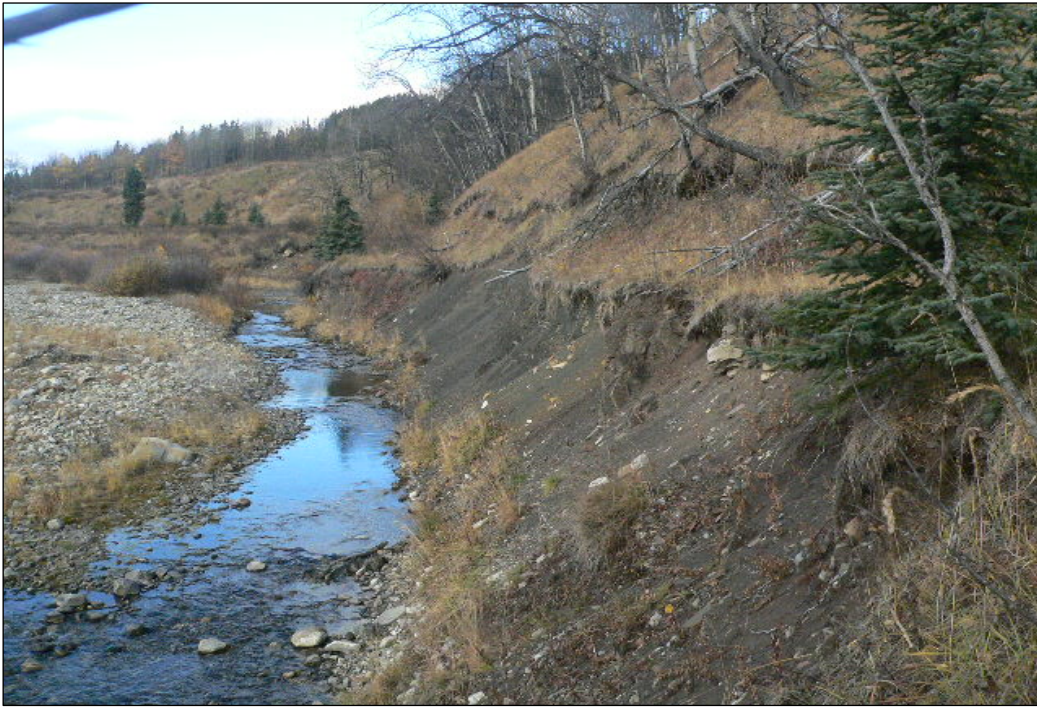
The original road route followed the north side of the creek, but portions of this route have since washed out (Figure 11). The washed out part of the trail can be seen in the foreground of the photo.

Figure 11: Washed out trail location along Nevis Creek at Nevis Camp.

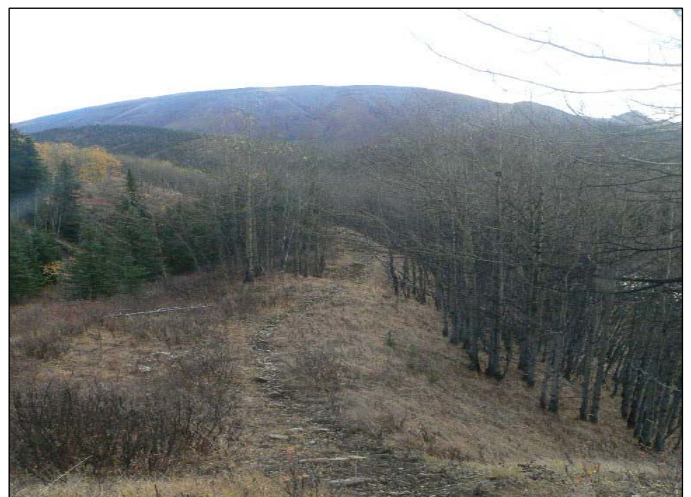
Figure 12: Hogs back alternative trail route location at Nevis Camp.

The total length of the new trail route would be about 800 meters. In order to establish this new route some minor construction would be necessary. This would include brushing and clearing of the hogs back to clear the brush wide enough to create an ATV trail and widening the top of the hogs back to allow ATVs to navigate the new narrow trail safely. At the bottom of the hogs back there is an intermittent stream that is best crossed using a short span ATV bridge.

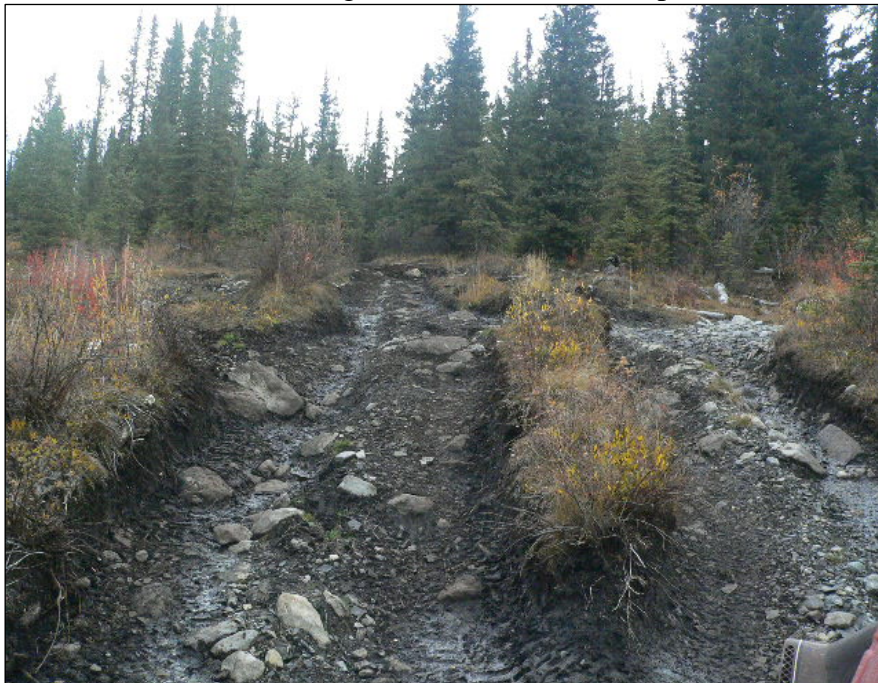
Ice Hill is located some 38 km west of the M-KMA boundary and one kilometre east of the boundary of Redfern-Besa Park. Trail damage at Ice Hill is extensive. The original trail followed the old road, however this route was washed out some time ago and now a series of alternative routes going directly down the hill are being used. The alternative routes are creating substantial ecological damage where the trails become eroded and runoff uses the trails as stream courses (Figure 13). Native vegetation vital to holding the soil in place on this sensitive site is rapidly removed by ATV use and erosion soon follows. Navigating down the hill can be difficult if not dangerous in dry conditions, as it was for us. In wet conditions the hill could be dangerous to the traveller. The ruts in this area are between one and two feet deep. These ruts are extremely rough with large rocks exposed. It is not uncommon for ATVs to become high centred on the centre piece between the ruts.

Figure 13: Trail braiding showing erosion and ecological damage at Ice Hill.

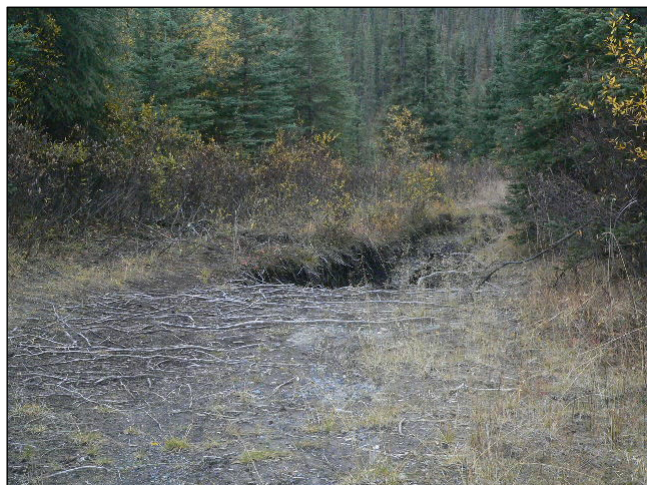
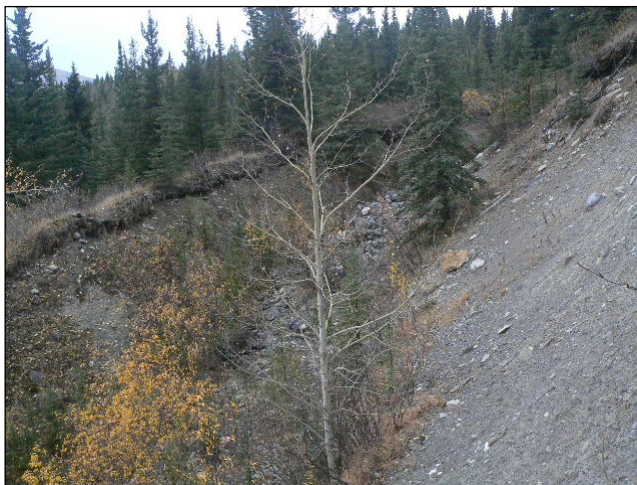
With a lack of use over the past years the gully is partly overgrown with willows, cottonwood and the occasional black spruce. Past the gully, lack of use combined with a relatively hard surface has likely helped to protect the original trail surface from further erosion and much of the original road is intact. Once again water management is the most important issue to deal with at this location, whether or not the current trails receive continued use. However, if the current situation is allowed to continue there will be further ecological damage to the hill (loss of vegetation and erosion). The loss of vegetation compounds the erosion problem, as the soils on this moist slope are sensitive to disturbance by nature of their parent material. Ice Hill soils are primarily colluvial materials, with minor glacial till overlaid with an organic layer. There is very little bonding material such as fine clays, intermixed with the coarse fragments. The organic layer and fine materials that are present are rapidly removed from the hill. One pass with an ATV in wet conditions will initiate erosion that could take years to repair. These finer materials are eventually deposited in the stream at the bottom of the ravine. This stream is of moderate size and even if it is not fish bearing, it flows directly into the fish bearing Besa River about 3 km away.

This loss of fine soil material then exposes the coarse colluvial under layers. These colluvial rocks are moved downhill by the actions of ATVs and water creating additional obstruction to ATV travel.

Figure 14: Original road bed at Ice Hill
Erosion Channel

Figure 15: Gully where original road bed is transitioning to an
washed out.

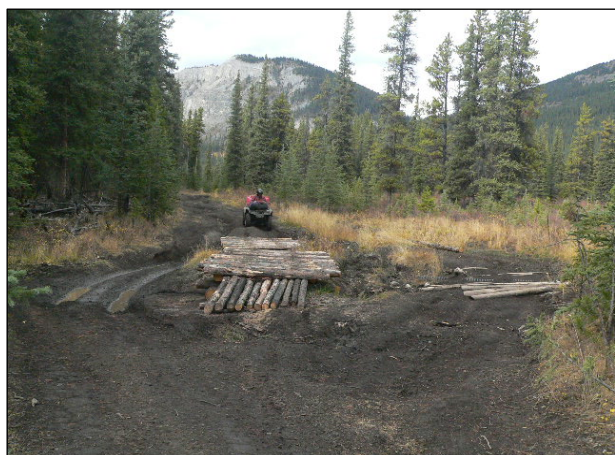
The general condition of the trail within the Park boundaries can be described as difficult. There are many deep mud holes and ruts from repeated use and erosion. This portion of the trail is different from the M-KMA portion as it has many smaller wetland crossings. The trail did not receive any maintenance for a prolonged period of time. However recently both FRBC and the Parks Staff have constructed corduroy from local materials at various locations to reduce damage and guide travellers. The condition of the trail is the result of its alignment crossing a succession of broad wetland drainages. A lack of maintenance, heavy ATV use in all types of weather combined with location has created significant impacts on these sedge wetlands. Throughout this park section, water management is the single most important issue. Water tends to remain on the trail for extended periods either in deep mud holes or in low laying wetland areas (Figures 16, 17).

Figure 16:
Drying mud
hole.

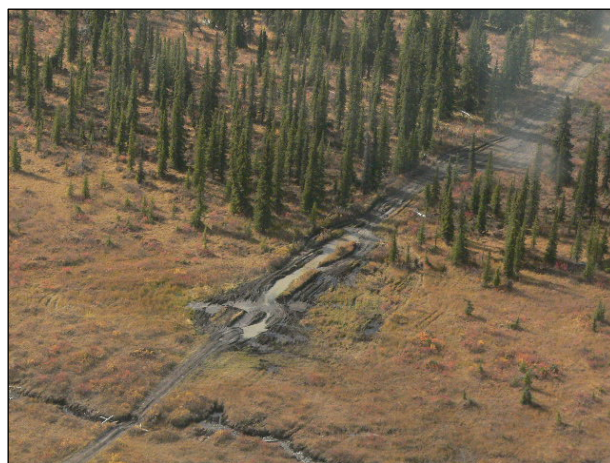
Figure 17:
Extended
lowland.
Water remains
on the trail for
extended
periods.

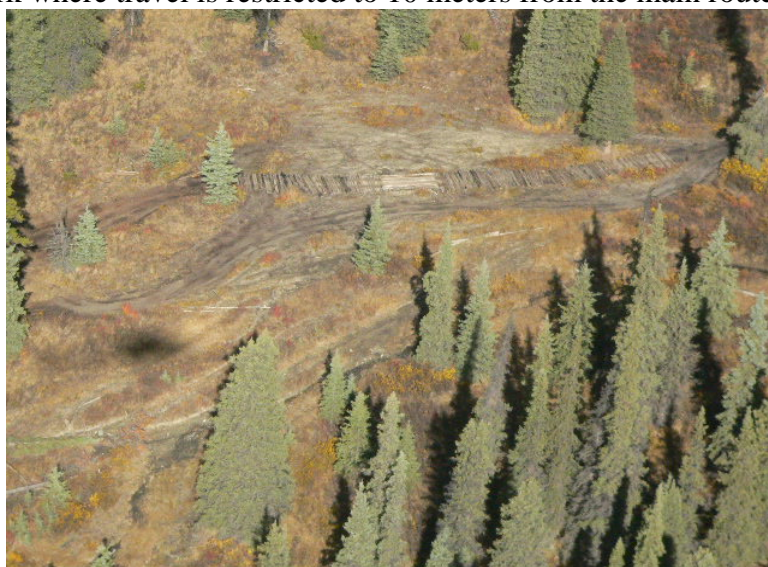
Attempts have been made to encourage travellers to use the corduroy with corduroy and simple bridges at the most severe wet sites; however these are not always used (Figure 18). We speculate the corduroy sections are sometimes avoided because the corduroy doesn't cover enough of the wetland, the rider believes the corduroy is unsafe or the corduroy is submerged and can't be located. Either way, riders continue to expand the area of disturbance by braiding out around the original route. Due to terrain, the greatest number of corduroy crossings occurs within the Park where travel is restricted to 10 meters from the main route.

Figure 18: Corduroy constructed trail route.

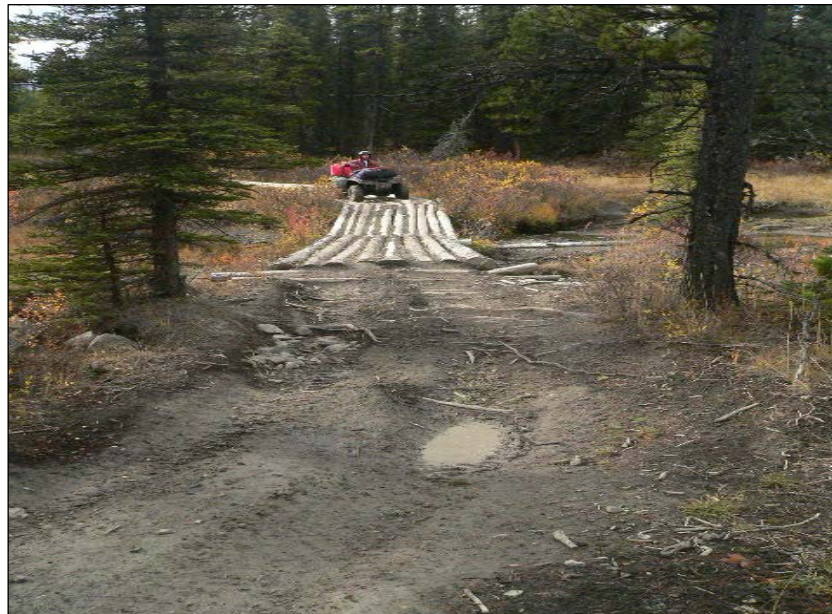
The corduroy construction within the park section is a specific concern for two reasons. First the corduroy is being cut from trees within the park without a common construction standard. Secondly, once in place it is apparent that travellers still navigate around the corduroy to avoid difficult conditions.

The use of the corduroy bridges also needs to be addressed. A system that identifies where the corduroy trail is located needs to be implemented to guide travellers over the bridges. During wet conditions the bridges may be extremely slippery. Getting off the ATV or losing contact with the bridge could be dangerous. Figure 19 illustrates the width and current construction of corduroy bridges in the Park. There is hardly enough width on the corduroy for an ATV; if one has to get off and stand beside the ATV they are likely to be standing in mud or water. If one was to miss or slide off the corduroy during passing over the bridge there is a risk of injury. These issues need to be addressed in a management plan and by a common construction standard for corduroy bridges.

Figure 19: Typical corduroy bridge in Redfern-Keily Provincial Park.

This project involves drafting up a standard design for corduroy suitable to the “rustic” nature of the trail, providing the quantities and materials list to put out a BC Bid request. We suggest treated materials flat on two sides (landscape ties) tied together with cable or bolts. The standard design should incorporate transitions at both ends. We suggest that materials can be purchased and stockpiled at Buckinghorse and flown to site in conjunction with other flights. Park staff could place the corduroy on an ongoing basis. Flight cost per 1000 lbs should be about \$ 1000.

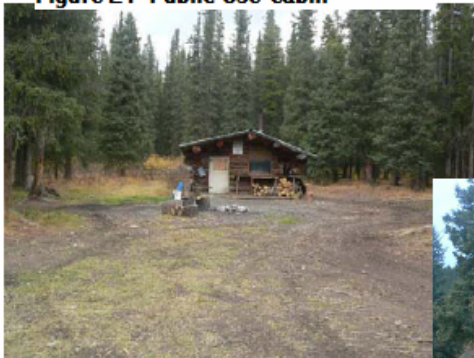
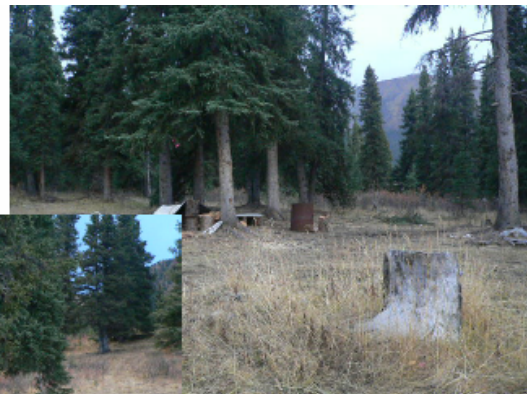
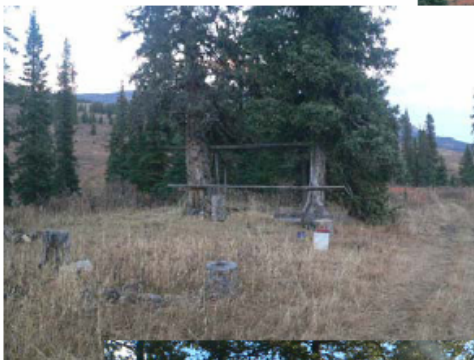
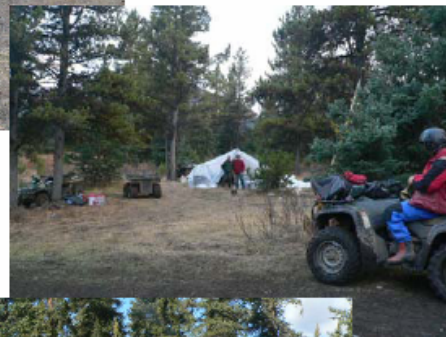
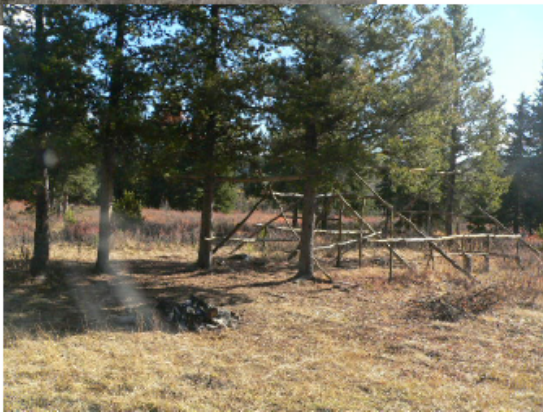
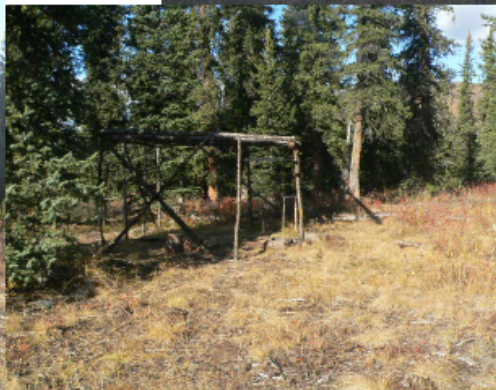
**Figure 22 Collage of
campsites encountered
September 2006**

Chillborne was requested to document campsites along the trail. Excluding the 3 commercial sites and the Public Use Cabin just east of Redfern Lake (Figure 21) we documented 26 non-developed camp sites. Only the site east of the Besa River Crossing had toilet facilities. Waypoints and Photographs for campsites are listed in Appendix C. A typical campsite was a fire pit in a grove of trees with a dry grassy under story that was near a source of water and/or horse feed. Quite often rudimentary tarp or tent frames had been constructed. In a couple of extreme situations considerable debris was left behind (See Campsite Collage Figure 22)
