**OVERVIEW FISH AND  
FISH HABITAT INVENTORY**

**UPPER MUSKWA RIVER  
WATERSHED GROUP**

**March 2002**

Prepared by:  
**Diversified Environmental Services  
Box 6263  
Fort St. John, B.C.  
V1J 4H7**

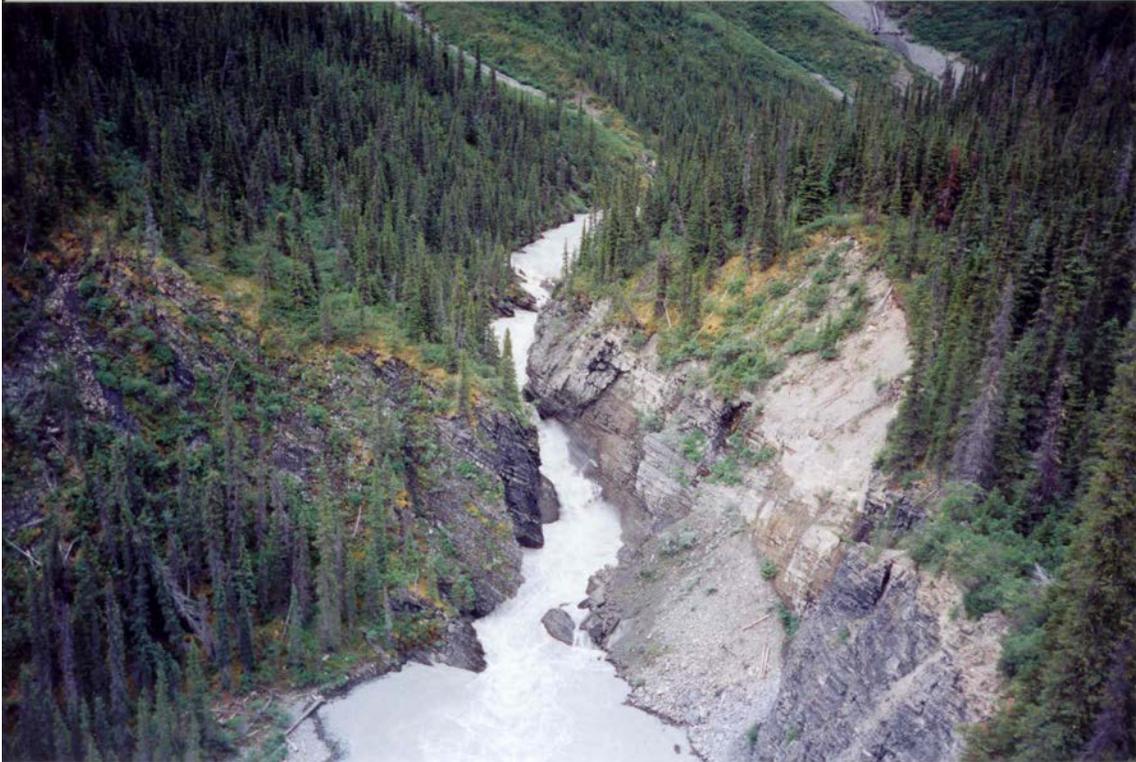
Plate 3: Third in a series of five barriers on the upper Muskwa River mainstem; upstream aerial view immediately downstream of the boundary between NRPP and Kwadacha Wilderness Park.

A 4-metre chute at the head of a narrow bedrock confinement, 65 km upstream from the mouth, defines the limit of fish distribution on the mainstem (Plate 6). Four additional mainstem barriers, between 2 m and 4 m in height, occur upstream of this impasse. Four mainstem and tributary sites were sampled upstream of the lower impasse. No evidence was found suggest the presence of an isolated upstream-resident population, despite the presence of suitable habitat.

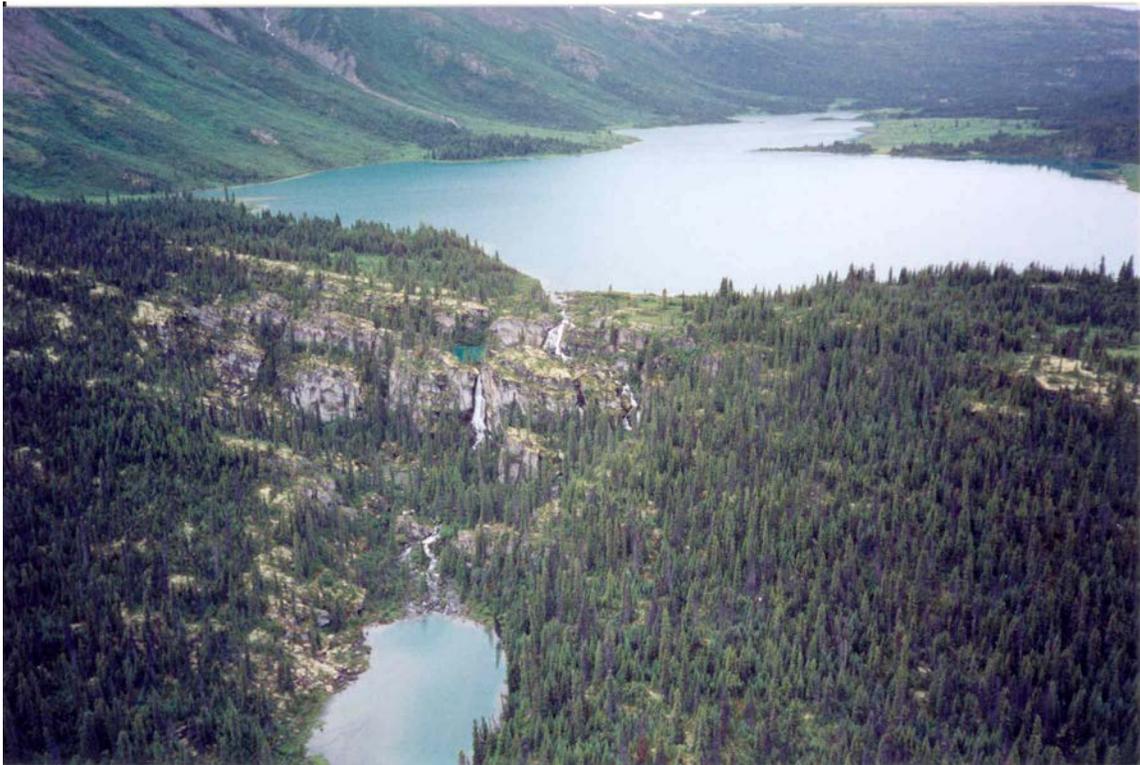
Plate 4: Impassable barriers between the outlet of Fern Lake and the upper Muskwa River mainstem; aerial view upstream to Fern Lake.

Rainbow trout are not native to the Fort Nelson River system and were initially introduced to Fern Lake during an unofficial transplant in 1966, the lake is believed to have been barren prior to this. Since then, seven additional stockings have been conducted by BC Environment (Woods 2001). The population appears to have remained entirely lake-resident and spawns in a 30-metre section of stream at the outlet of the lake, immediately upstream of a series of major impasses which descend into the upper Muskwa River mainstem (J. Burrows, pers. com.) (Plate 4).

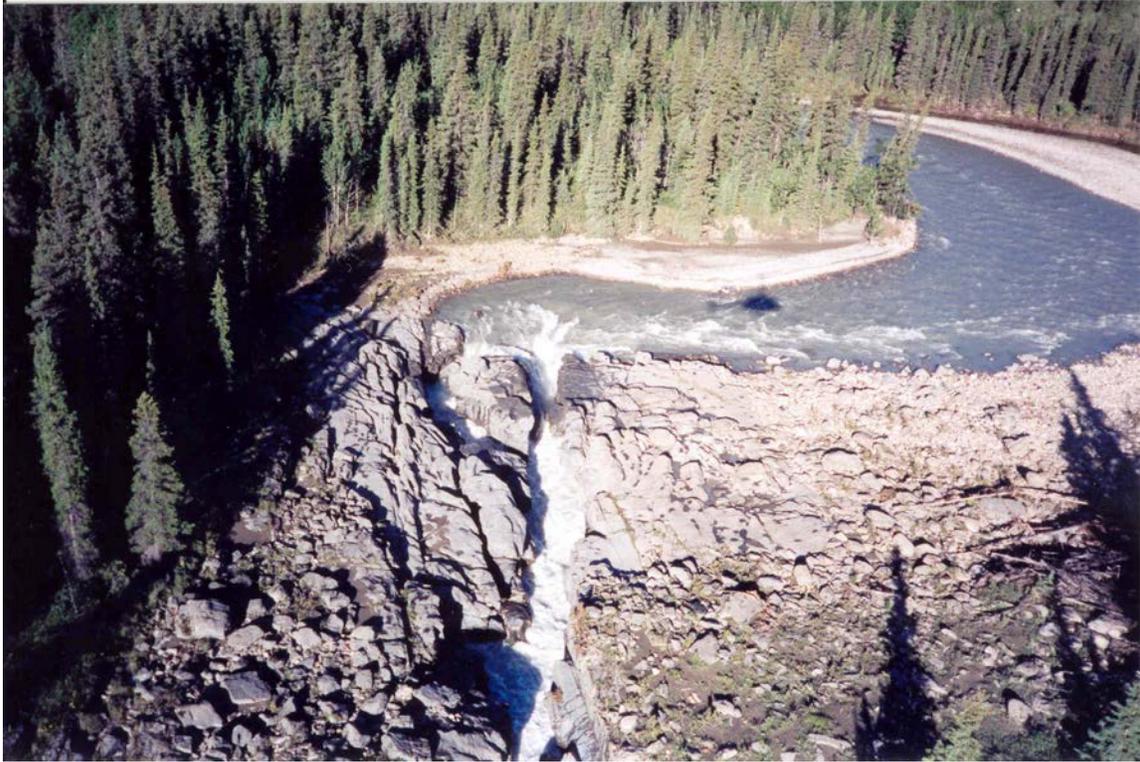
Plate 6: Impassable barrier defining the upstream limit of fish distribution on Gathto Creek; upstream aerial view.

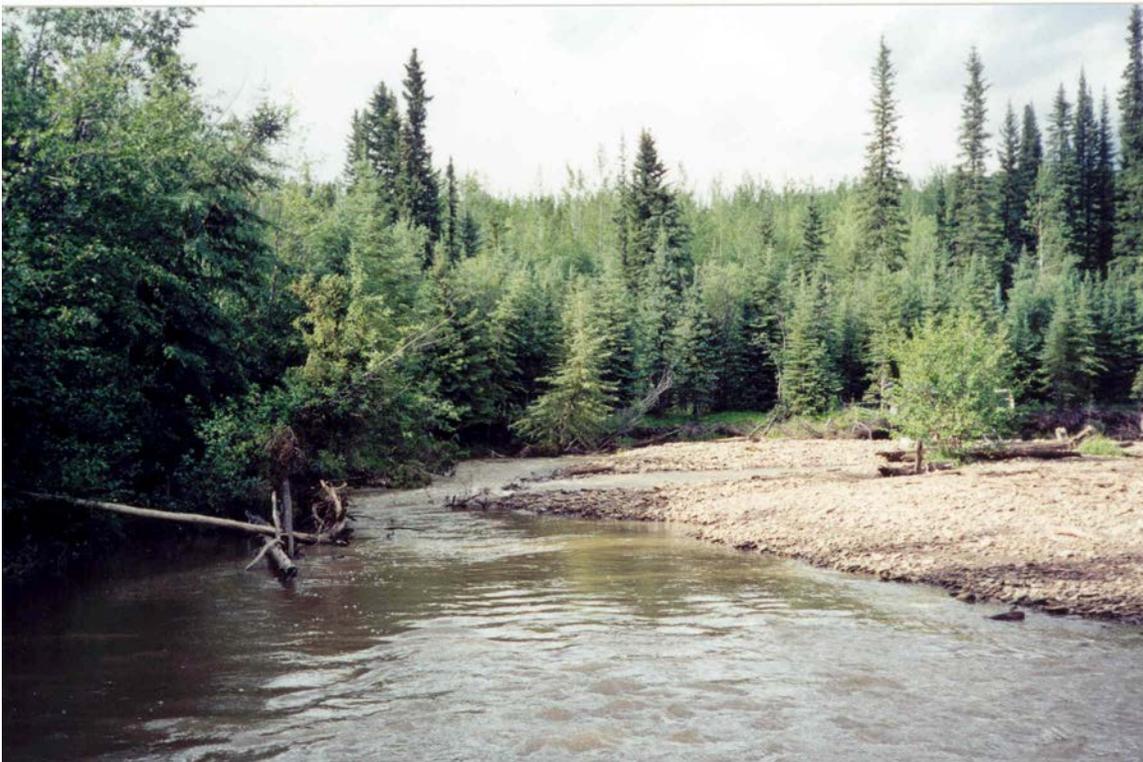
Plate 8: Typical Taiga Plains seasonal rearing habitat occupied by juvenile Arctic grayling and mountain whitefish; view upstream on unnamed Muskwa tributary adjacent to Pentreath Creek (site 23).

Muskwa River tributaries in the lower portion of the project area lie within the Taiga Plains ecoprovince, to the immediate east of the Rocky Mountain foothills. Light to moderate turbidity levels result from suspended sediment and organic stain. Streambed substrates typically contain a significant proportion of fines and summer water temperatures are slightly warmer than in the western section (Plate 8).

These factors contribute to limitations on suitability for bull trout and none were encountered during the survey. Seasonal rearing potential for Arctic grayling and mountain whitefish is moderate to high and both these species were found to be relatively abundant, with a wide range of age classes represented.

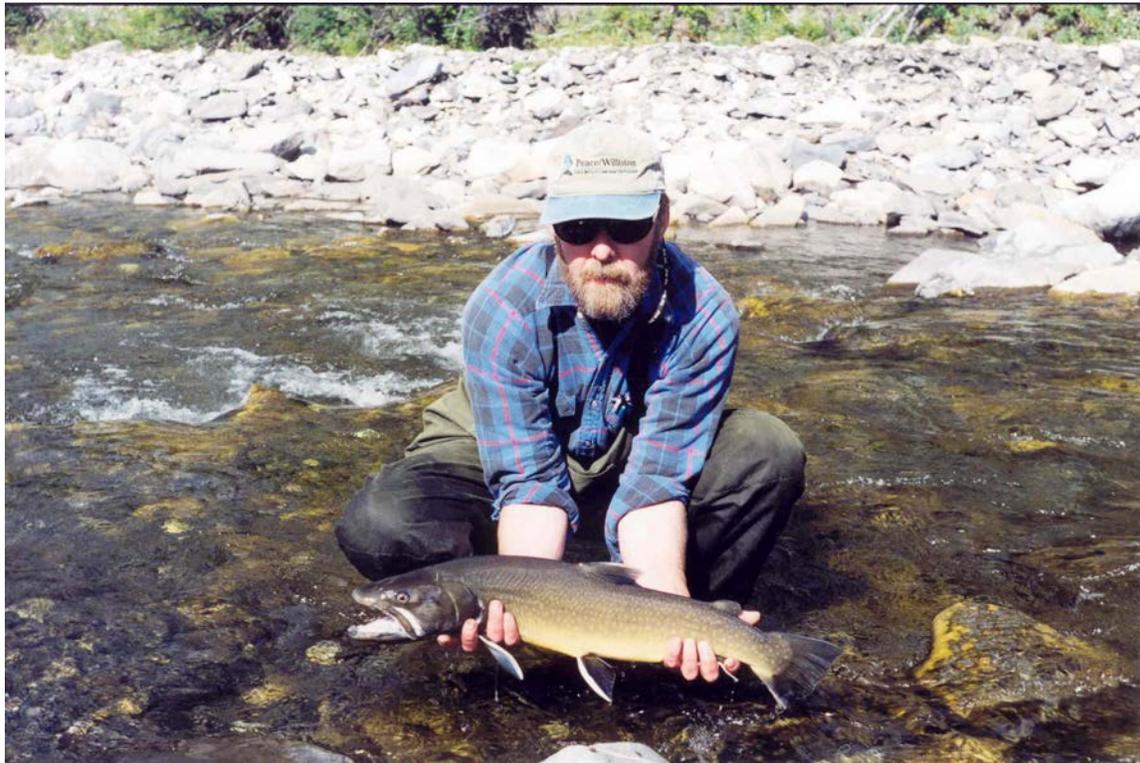
Plate 9: 700mm male bull trout spawning in unnamed tributary to Crehan Creek (212-580800-71000-47800) (site 30).

Anecdotal information (T. Vince, pers. com.) suggested that Crehan Creek contained critical spawning habitat used by fluvial, migratory bull trout. On July 26, 2001, a sexually mature adult female and a YOY juvenile were captured on the lower reach of the mainstem (site 29) confirming this suspicion. On August 27, an aerial search of potential bull trout spawning habitat within the Crehan Creek drainage was conducted in conjunction with the Muskwa River bull trout spawning assessment (DES 2002). Moderate densities of spawning adult fish and active redds were located on a 600 m section of unnamed tributary 212-580800-71000-47800 (site 30) (Plate 9).

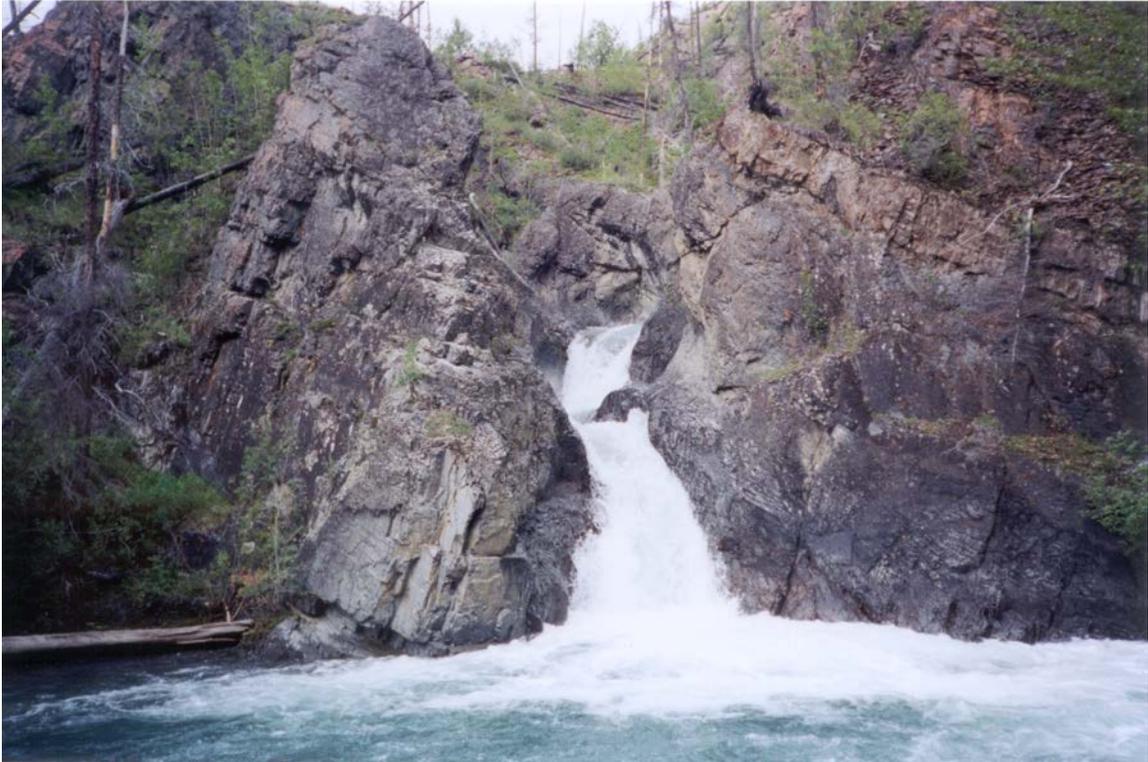
Unnamed tributary to Muskwa River  
Site 36: View upstream; barrier at top of site – 4m x 4m  
(Roll UM3 - Exp 2; CD 2 - Im 149)

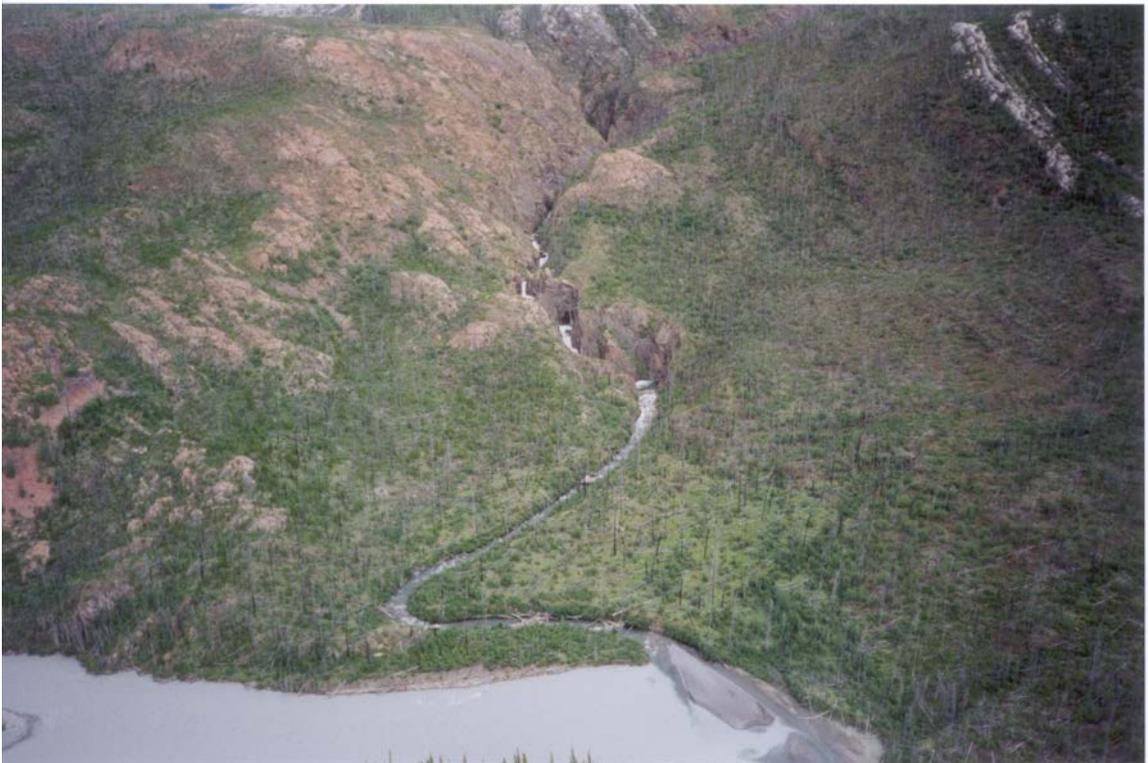
Unnamed tributary to Muskwa River  
Site 36: Aerial view upstream; barrier at top of site – 4m x 4m  
(Roll UM3 - Exp 3; CD 2 - Im 150)
